Recording St Mary's Churchyard, Norton, 2021 – Monuments

Maureen Norrie, TAS committee member

Introduction

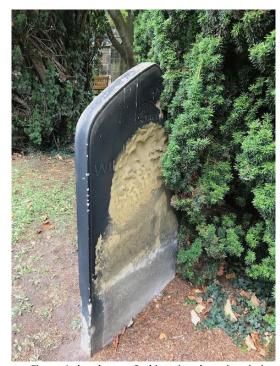
Figure 4: headstone, Gothic pointed top, inscription almost completely eroded by yew tree

Whilst many inscriptions remain in excellent condition, some are now semi-legible or almost illegible. Several (especially on sandstone) are severely eroded through weathering and local pollution – and in cases, by abrasion from yew tree branches. Groundwater commonly affected lower parts of the inscriptions, causing them to become less legible. A few monuments have sunk a few inches into the soil, again causing lower parts of the inscriptions to be lost. On the other hand, one monument is covered in greenish algae: this has not only protected the inscription, but also makes it easy to read.

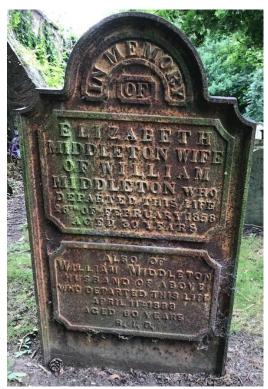
Figure 6c: cast iron monument

Most of the monuments are of stone. The single exception is a cast-iron monument, erected by one William Middleton to Elizabeth, the first of his three wives, who died in 1858. Census data shows William Middleton was a 'pattern maker' in the local iron works: that is, he made the 'patterns' or preliminary moulds, used to make the final moulds that were then used to cast iron. As such, this is a very personal memorial to his wife.

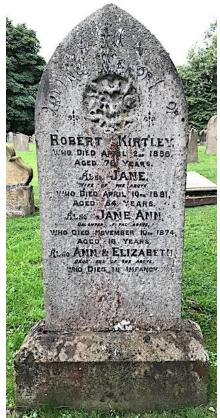
Figure 8: 'standard' sequencing of names inscribed at the one time, regardless of death date. First, father/husband; second, mother/wife; followed by children. Father/husband's name comes first, although (here) he died last (1896)

Matters are more complicated on headstones and horizontal monuments. One factor is sequencing of names. In 19th century (and older) monuments recorded here, a standard sequencing – regardless of date of death - was used when names of several family members were carved at the one time. First named was husband/father, second was wife/mother, and these were followed by their (young or adult) children's names. In this case, the relevant date is that of the most recently-deceased, coded as '3: inferred date from the latest date of a group first inscribed together'.
